# Nelson-Atkins Museum of Art

case study  
By Cameron McRae

Location: Kansas City, MO

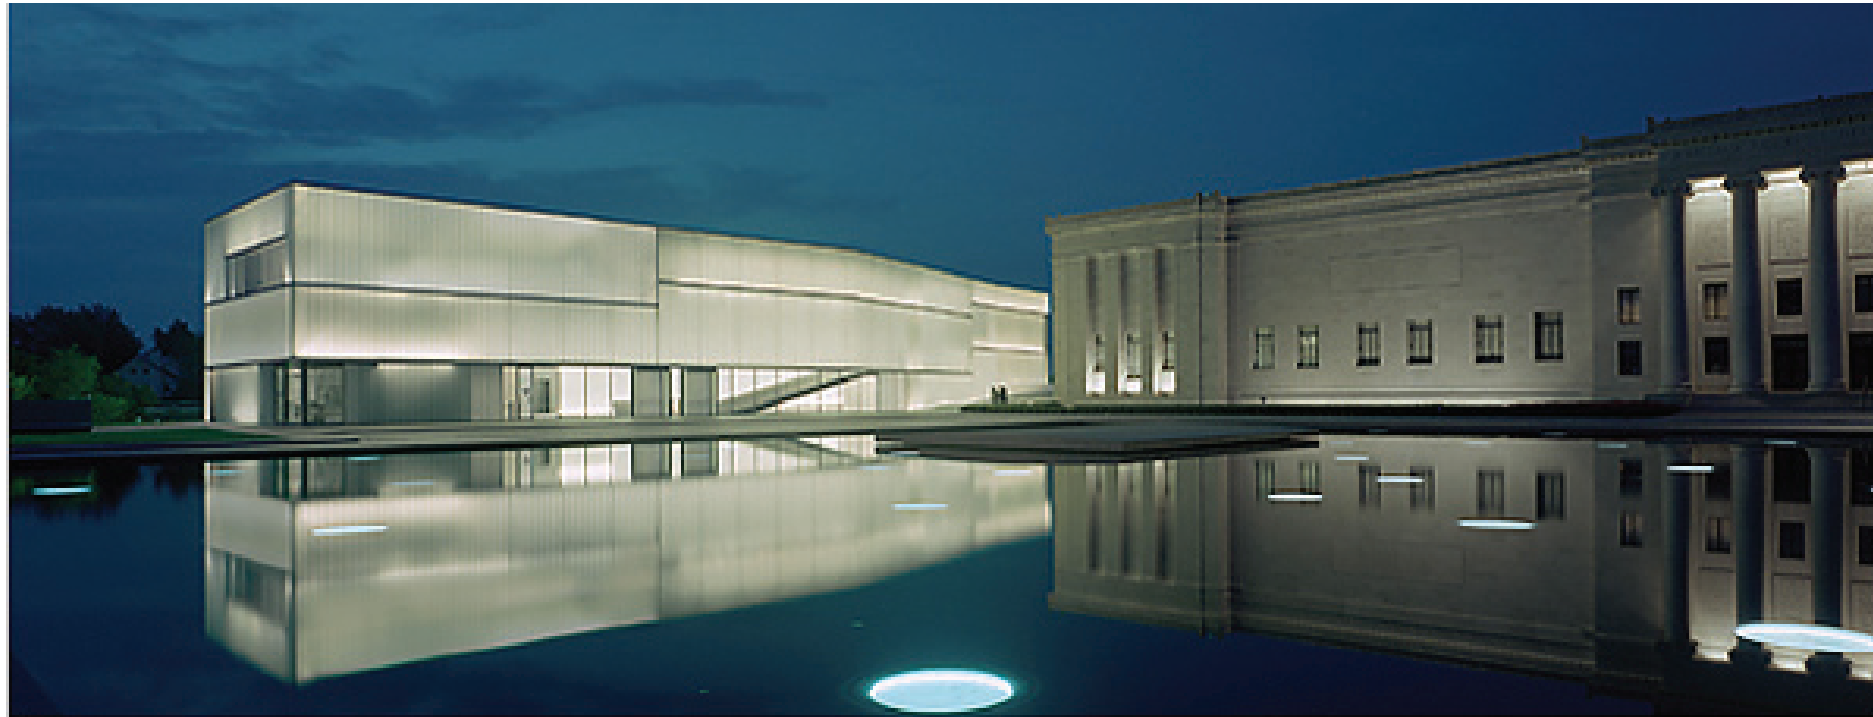
**Material of interest:** Okalux Capillary Glass

**Properties of material:** Made from a series of tubes sandwiched into a sheet of glass. Transmits and difuses light in a uniform manner and reduces glare and heat loss due to the insulating cavity within each tube.
